Engine Management

Comprises the management of engineered activities; fuel delivery, air/pressure, coolant, acuta-tion(exhaust controls), occurrences analysis/recording/reporting(gages)

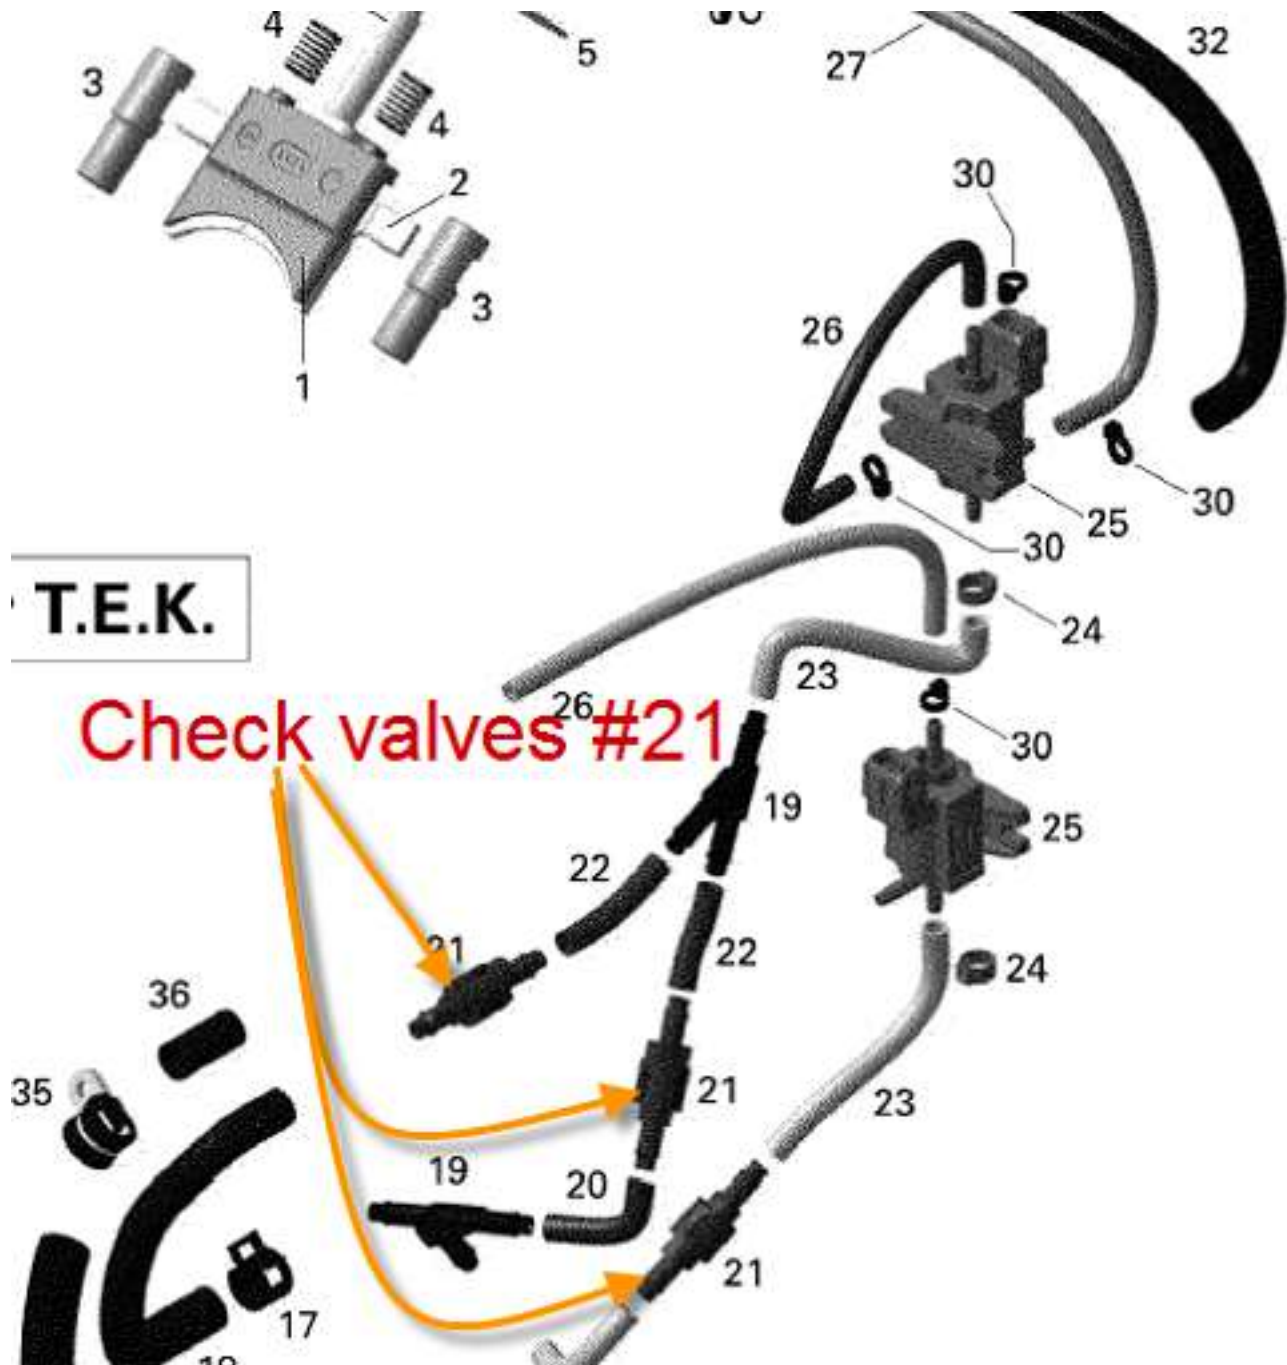
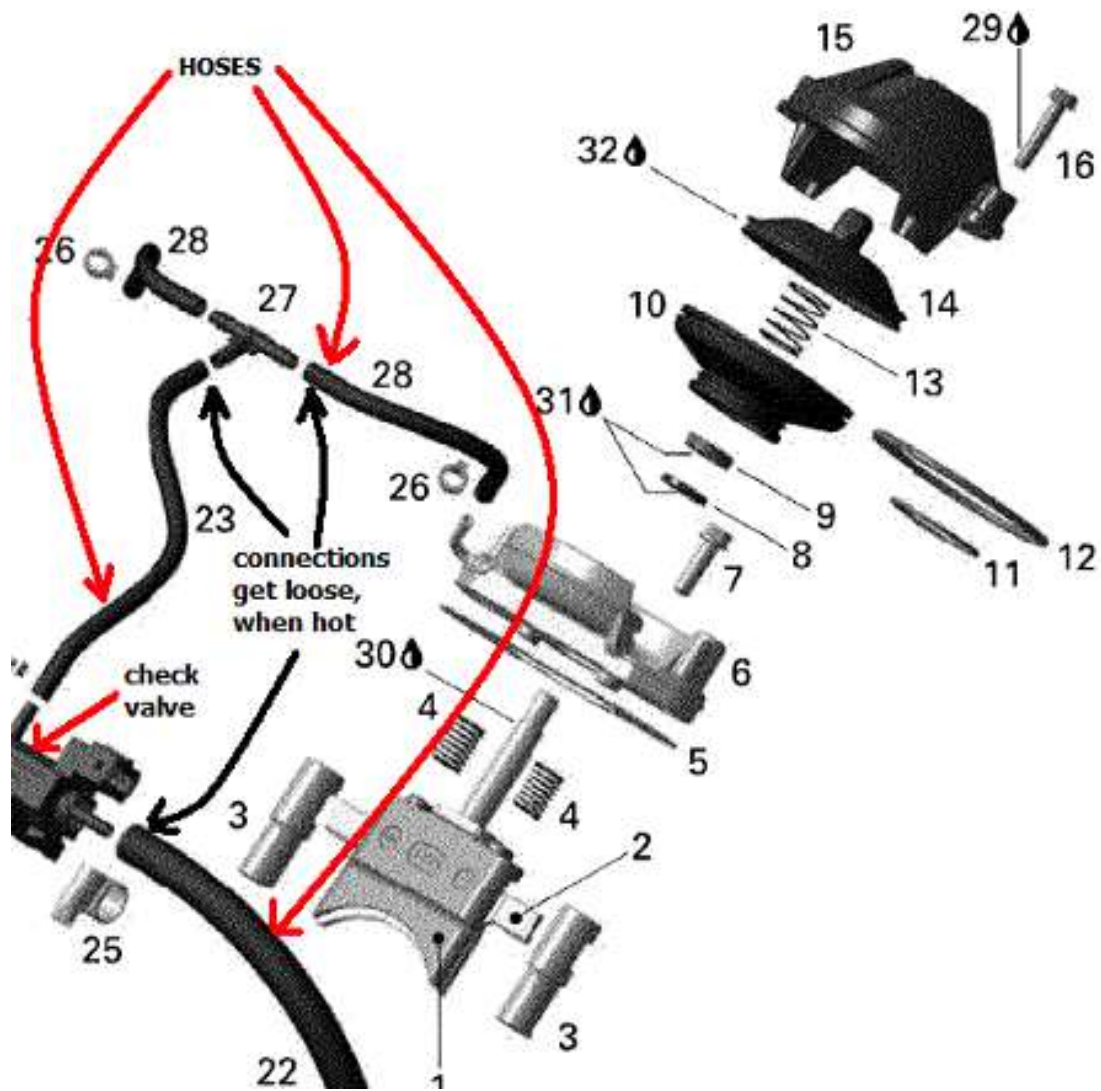
Rave Check Valves

Events - (Engine will reach maximum rpm only for a moment) The sled would pull well for 2-3 seconds, then rpms start drifting low forcing you to turn out.

1)Ensure that all rave check valves are phased in the proper direction.

2)Check valve leak test - Install test pump and pressure to 5psi. Valve should stand pressure. Install pump opposite side, pump, air should flow freely.

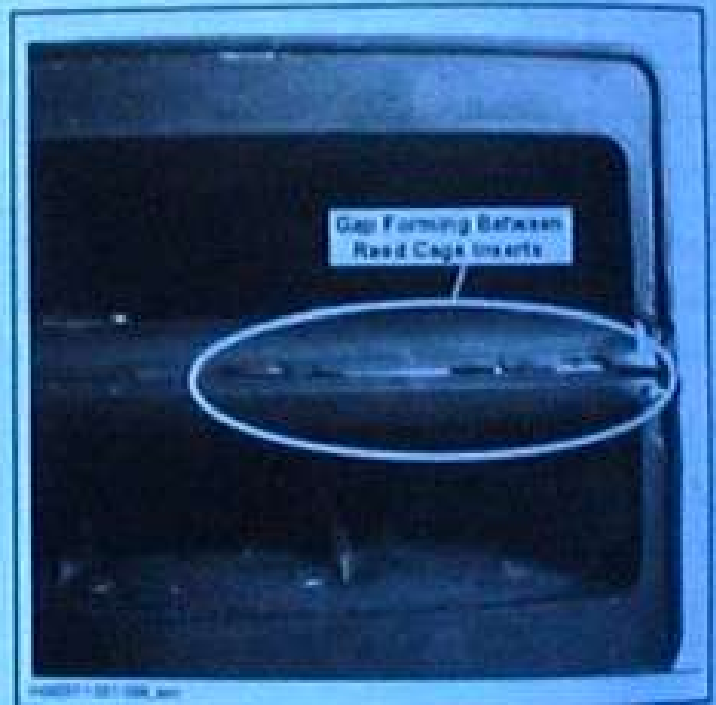
800R REED CAGE INSERTS MATING SURFACE GAP

The 800R engine platform uses a high air flow dual V type reed cage design where there is an upper and lower reed cage insert to implement the use of twelve reed pedals. On some 800R snowmobiles there have been reports of poor idling, poor RER function, poor fuel economy, lack of mid-range performance or lack of wide open power. It has been found that any of these conditions can be related to the reed cage inserts coming apart where they should seal together when installed in the cylinder.

So when inspecting the reed cage inserts always pay extra attention to see if there is a gap forming on the mating surfaces of the reed cage inserts from delamination or vibration which can affect primary compression. Borderline sealing RAVE solenoids or slow reacting RAVE valves may be a sign that the primary compression has been compromised on an 800R engine. See the technical tip in this section on slow reacting rave solenoids. Normal warranty applies.

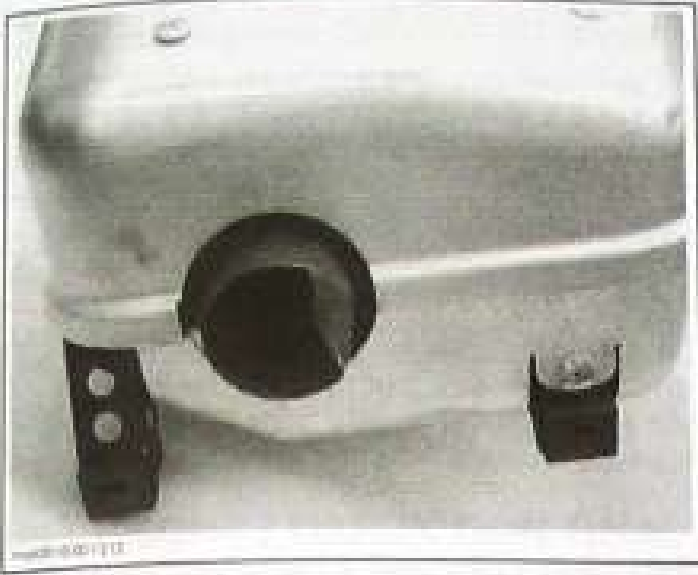
AFTER-MUFFLER OUTLET DAMAGED FROM IMPACTS

Technicians sometimes overlook a basic inspection point when diagnosing a snowmobile that doesn't rev to full rpms or doesn't have full power. By just inspecting the exhaust after-muffler outlet, it can easily be seen if there has been rock, stump or other impact to the exhaust outlet.

If the after-muffler-outlet is bent inward, the exhaust flow can be obstructed which can affect the way the engine breathes and can adversely affect engine performance. If the exhaust after-muffler outlet is bent, normally it can be straightened back to its original shape enough so it does not obstruct exhaust flow. If the damage is so severe to the outlet that the bottom of the after-muffler is bent, it is possible that there has been internal damage done to the after-muffler. In this scenario the after-muffler should be replaced. For race conditions, the Rev-XP 600 RS race sled comes with the addition of a snow deflector that can aid with additional protection for the after-muffler outlet on standard production Ski-Doo snowmobiles. This snow deflector is available through the BRP PAC department. Warranty does not apply.

If outlet is obstructed by dent, then straighten and look inside to inspect for internal damage to the inner wall to further see if deeper obstruction.

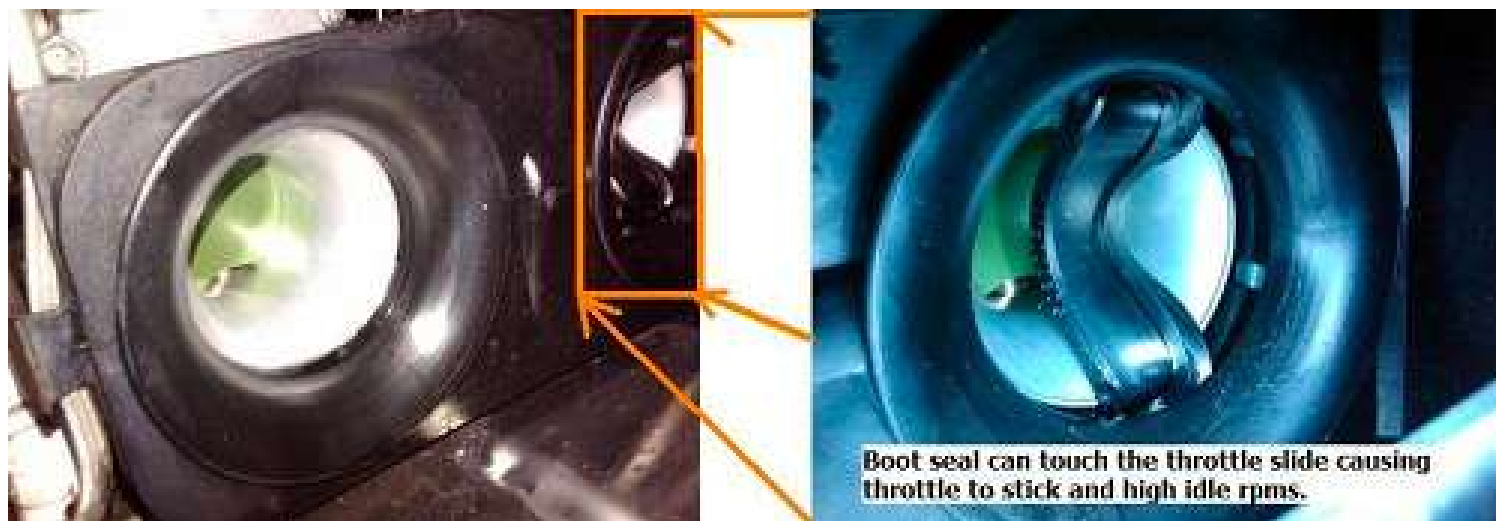
Throttle sticking (possible causes)

Deformed Air Intake Adapter - Boot seal can touch the throttle slide causing throttle to stick and have high idle rpms. (well known to happen on 09/10 models)
