Engine Management

Comprises the management of engineered activities; fuel delivery, air/pressure, coolant, acuta-tion(exhaust controls), occurrences analysis/recording/reporting(gages)

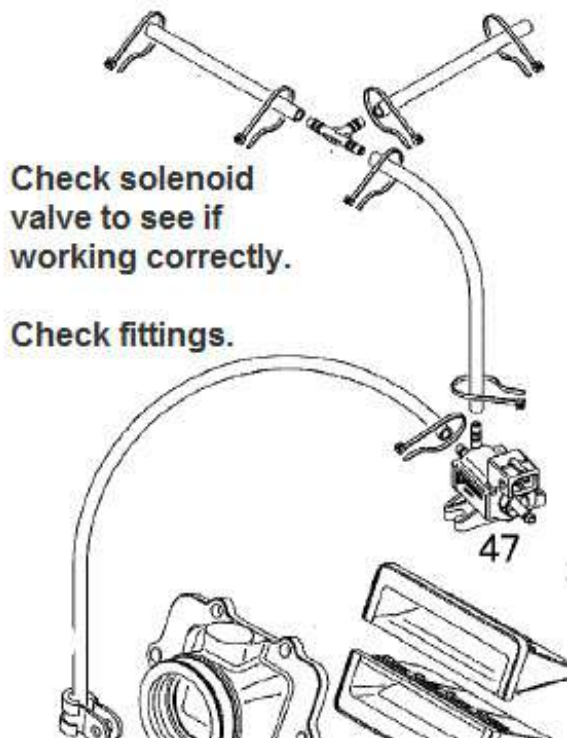
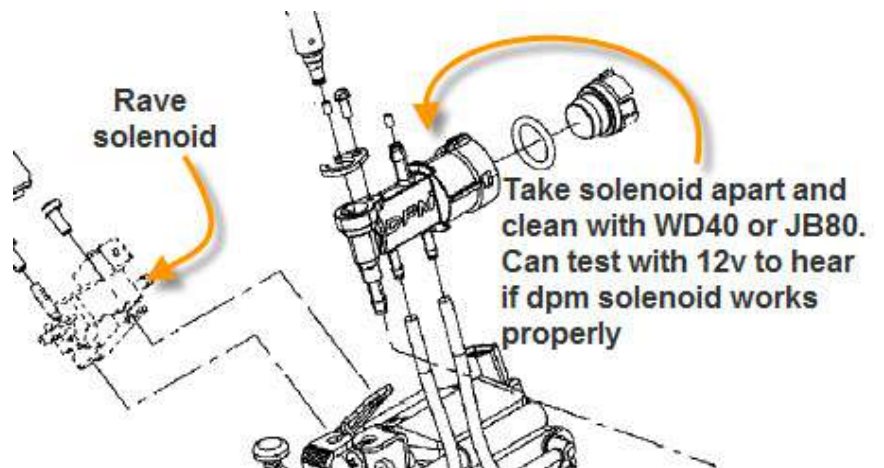
800 PTEC engine

SLOW REACTING RAVE SOLENOIDS – POOR FUEL ECONOMY AND POOR PERFORMANCE

There have been reports on units with either the 800R Power TEK, 600 E-TEC or 800 E-TEC that either the fuel economy had fallen off or the performance had fallen off in certain RPM ranges. Some units were reported to have both of the issues. From the reports received back from those involved with these complaints, it was found that all of the testing as per the shop manual was correct. **Except for, when watching if the RAVEs were going through the three positions with the RAVE caps off, it was noticed that the RAVE valves were very slow reacting going from one position to the next.** In many of these cases there were no vacuum or pressure leaks found, the electrical activation to the solenoids tested good and the solenoids themselves tested to be good as per specifications. In most of these cases it was found by replacing the RAVE solenoids with known good RAVE solenoids the RAVE valves returned back to the quick movement through the three positions and the unit returned back to the original good fuel economy and good performance. From there it was isolated to which solenoid was causing the issue by swapping out the front or back to figure out which one was actually the bad part. RAVE solenoids that are found to be slow reacting or borderline sealing internally may also indicate an issue with the sealing of the reed cage inserts or the reeds themselves which may have a small effect on primary compression which is used to apply vacuum and pressure to the RAVE solenoids.
